**Flood Control Project Maintenance
Levee Inspections**
LMA District Cover Sheet
Spring 2017 Levee Inspection Results

Reclamation District No. 2060 Hastings

Spring 2017 Levee Inspection Results

Levee Inspection Report By Mile - Spring 2017

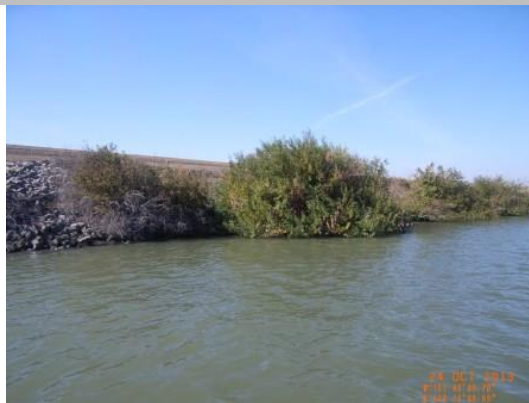
Photo 1 of 1 : SP_2017_RD2060_243_5_20170404_00004.jpg

LM Start	2.55	Rating **	M	Issue No.	5
LM End	2.58	Issue Type +	Ma	Location *	WS
Category	Supplemental			GPS Latitude/Longitude	
				Start	End
Item	2015 USACE Erosion Survey, DRAFT			38.278145 °	38.277774 °
				-121.712609 °	-121.712137 °
DWR ID	DWR_RD2060_03_s_2016_5				
Comment Code					
Inspector Comment					
2013 - Erosion pockets into the levee toe. 2015: Erosion pockets have increased in size. [2015 Site ID: CHS_22-5_R]
